Condition Assessment Aberhosan Community Centre

Thursday, 17 March 2016

Prepared For Liz Trow

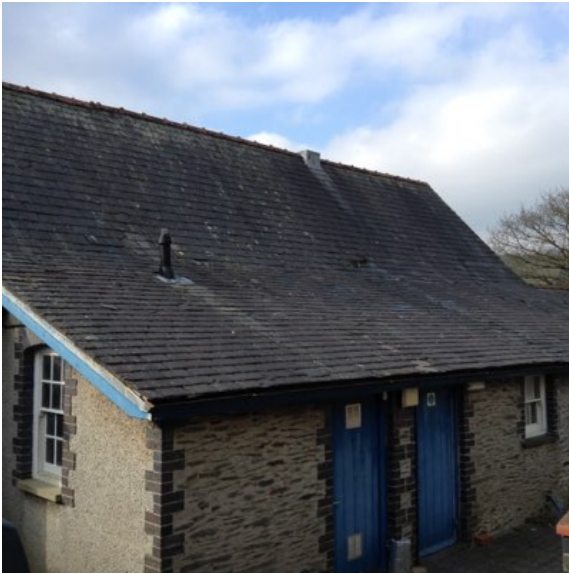
SLATE ROOF. (235 Sq Mtrs)

There are many broken missing or slipped slates on all elevations of the slate roof. Many slates have been replaced on Lead hanger and because of the position of the building these hangers have failed.

The Cast iron Ogee guttering is leaking on several elevations and missing on the front elevation.

The Soffits fixed to the open eaves is rotten in several places where it is abutting the Barge Boards and generally in a bad state of repair.

The Barge Boards are in a bad general state of repair and attempts to repair have been made in the past.

The inside of the roof has been close coupled and there doesn't appear to be an access point, so the condition of the Timber roof structure is unclear.

There is evidence of water ingress and damp areas on the inside of the roof.

Without damaging the inside of the plaster work to access the Close Coupled roof it is unclear if there is any insulation in the roof.

The roof would benefit from the addition of proper under cloak verges to help stop the wind damage to the gable elevations.

The roof needs to be refurbished to include :-

Slates taken off to be reused.

New lathes sarking felt.

New under cloak Verge or dry verge system.

Insulation between rafters and in close coupled roof space.

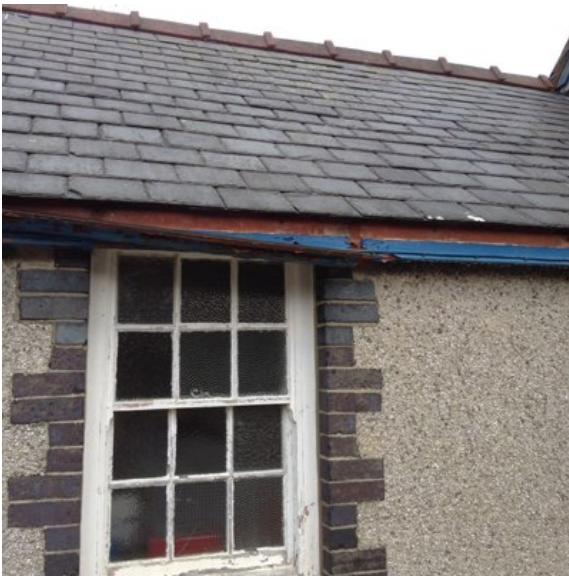
GUTTERINGS.

Missing Guttering to the front elevation.

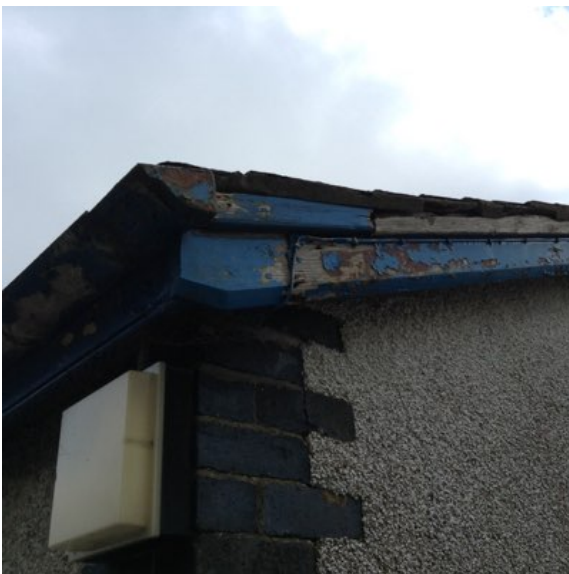
BARGE BOARDS AND VERGES.

Rotten Barge Boards and Missing Verge.

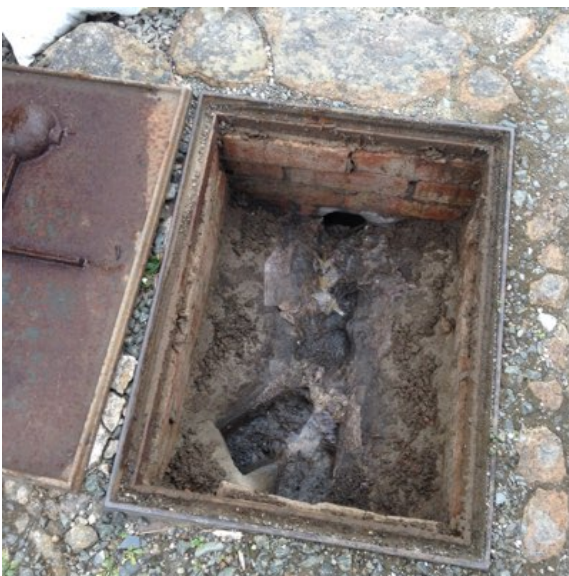
STORM AND FOUL DRAINAGE

The Drainage system is combined with foul and rainwater sharing the same pipe work.

This appears to be blocking on a regular basis all inspection points show signs of sewerage backing up in the past.

The system would benefit from a specialised drain survey to establish the problems.

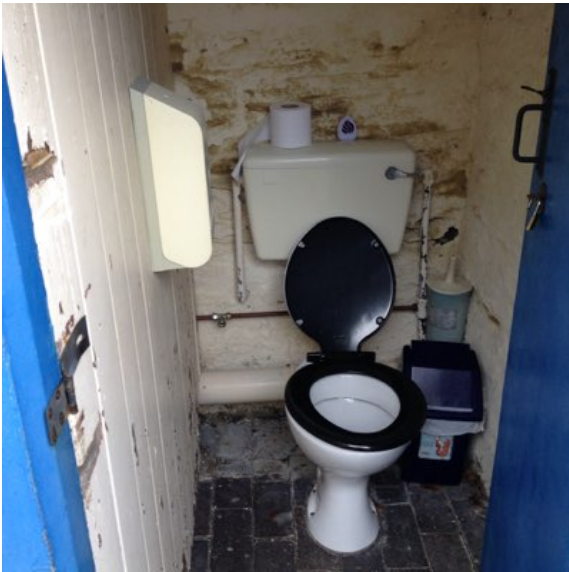
TOILET ONE.

The external Toilets are very damp and the whole of the building is not ideal to be used as Toilets. There are no hand washing facilities in both of the Toilets.

The Blue Brick paved area from the Toilet to the centre is very uneven and there are many trip hazards.

The whole area of Blue Brick Pavers need to be relayed.

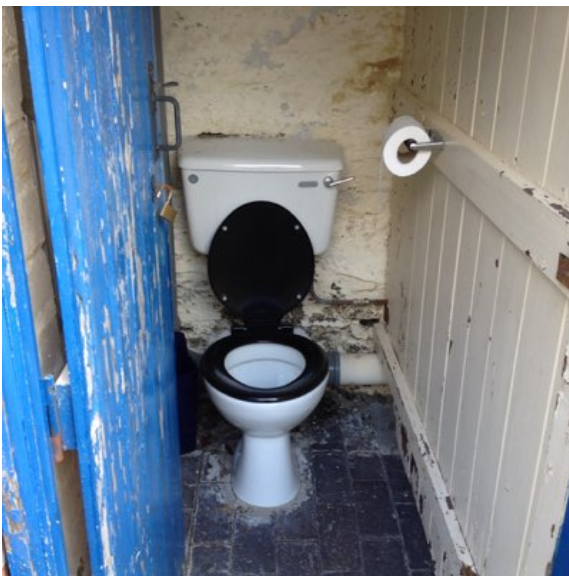
TOILET TWO.

Second Toilet.

I would recommend that the two toilets are removed and relocated to a purpose built area in the rear store within the main building.

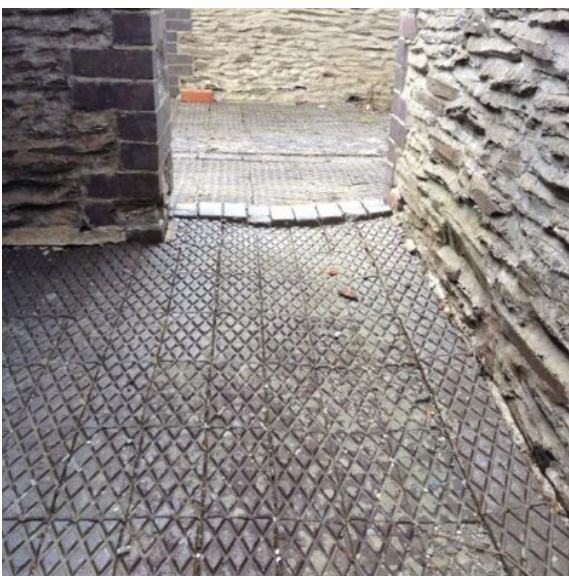
TOILET PAVED AREA.

Trip hazard on pavers.

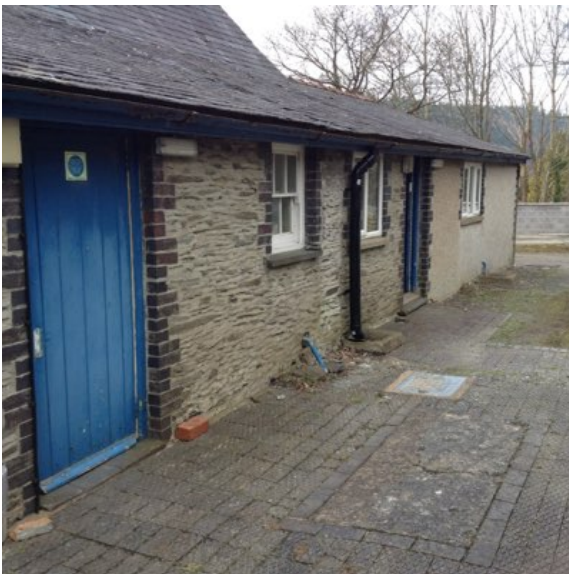
REAR ELEVATION.

Two windows have been replaced with UPVC.

Two further Sash Windows need to be replaced with UPVC.

Three external Doors would benefit from a upgrade.

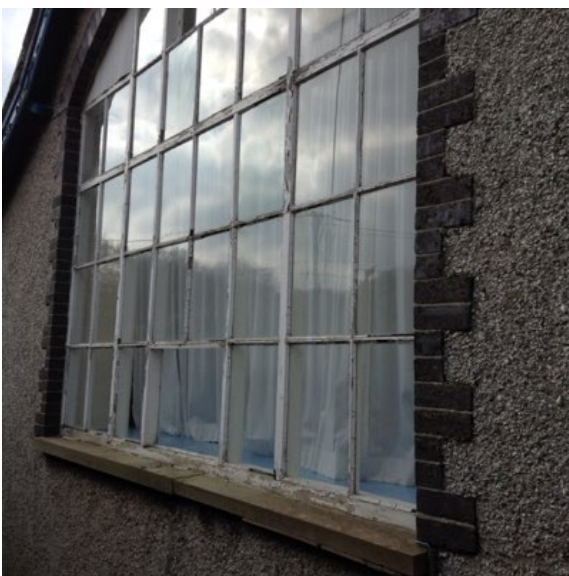
SIDE ELEVATION WINDOW.

This window needs to be replaced very rotten.

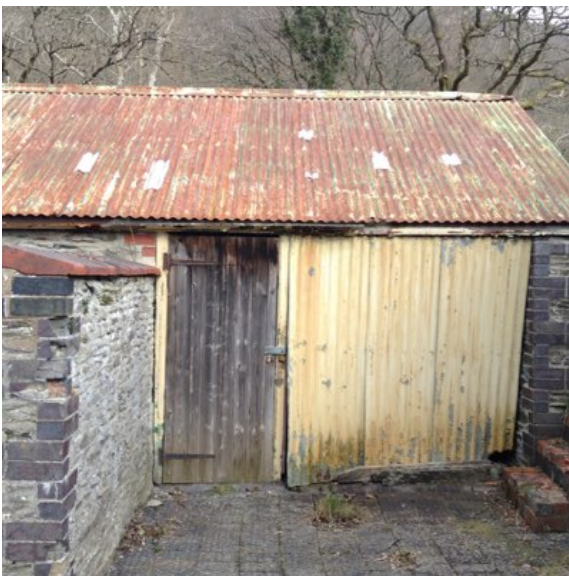
REAR STORE.

These out buildings are in a very bad state of repair and would not make economical sense to repair. I would recommend that the Toilets are relocated to the main building and brought up to current regulations and the out buildings demolished.

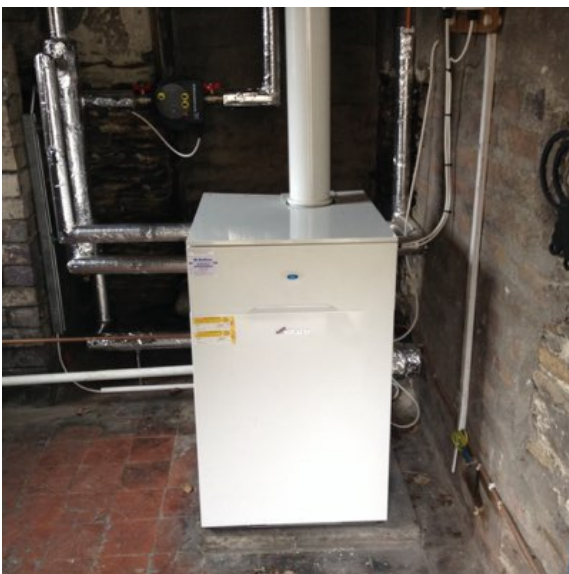
HEATING SYSTEM.

The heating system has been updated recently.

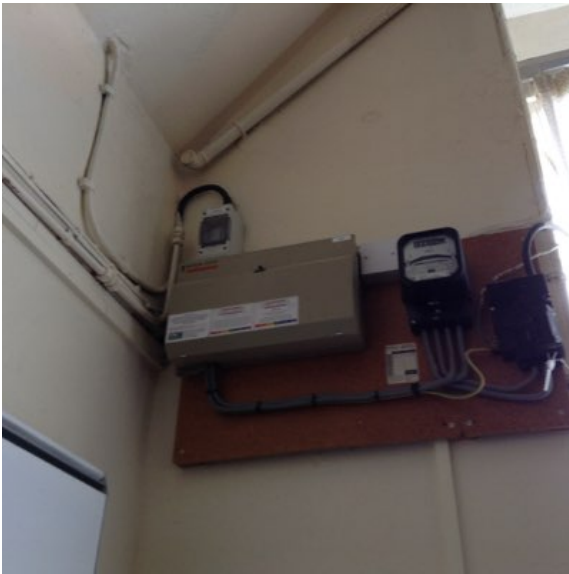
ELECTRICAL INSTALLATIONS.

The electrical installations seem OK and have been checked on a regular basis.

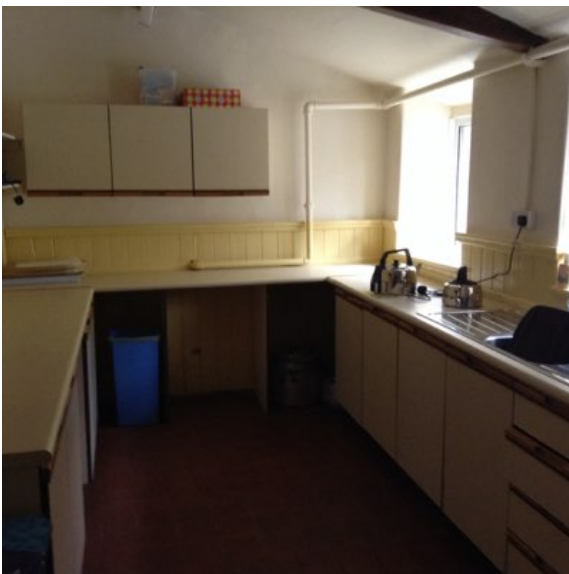
REAR KITCHEN.

All seems ok dated but functional.
Possible upgrade to Kitchen units and redecoration.

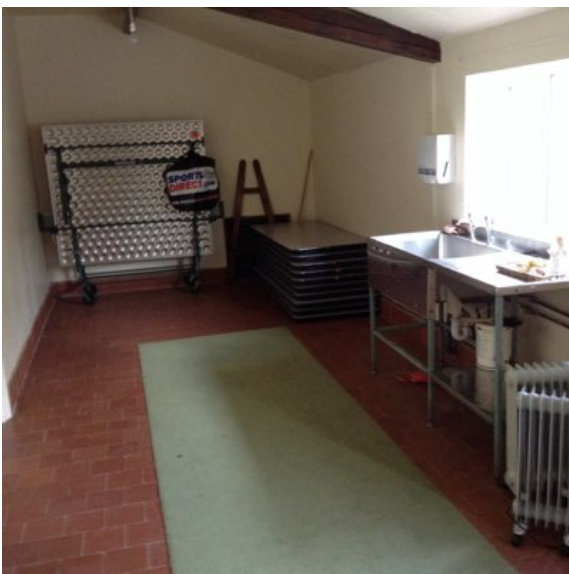
REAR STORE.

Dated but functional.

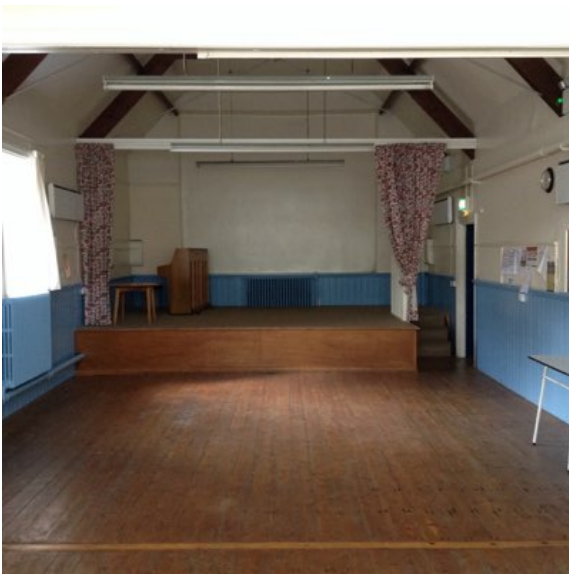
MAIN HALL.

Dated but functional.

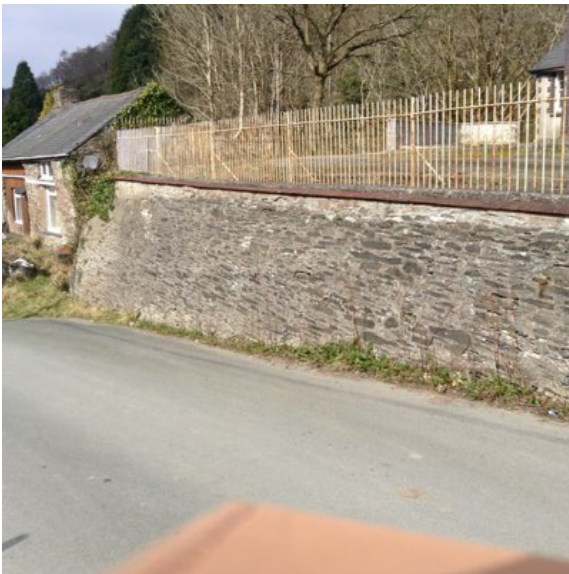
RETAINING WALL.

This retaining wall was looked at in June 2014 following concerns from the centre that there was cracking and movement to the wall. a part report was compiled by an structural Engineer which was inconclusive regarding any movement. it is unclear how the wall was constructed in the first place, whether it was built as a dry stone wall and the stonework pointed with cement based mortar and lime based mortar at a later date. there has been no further cracking or movement since June 2014.

This Wall should be monitored for any further signs of movement. I do not feel that there is any significant risk with this wall.
