Steve Ambler & Sons Tree Specialists Limited

East Street. Rhayader.			
Date	28 th February, 2022	To	Mr. Steve Gealy (Powys County Borough Council)
Subject	Resistograph & Fractometer Decay Detection Testing on a Single Pedunculate oak (<i>Quercus robur</i>)	cc

INTRODUCTION

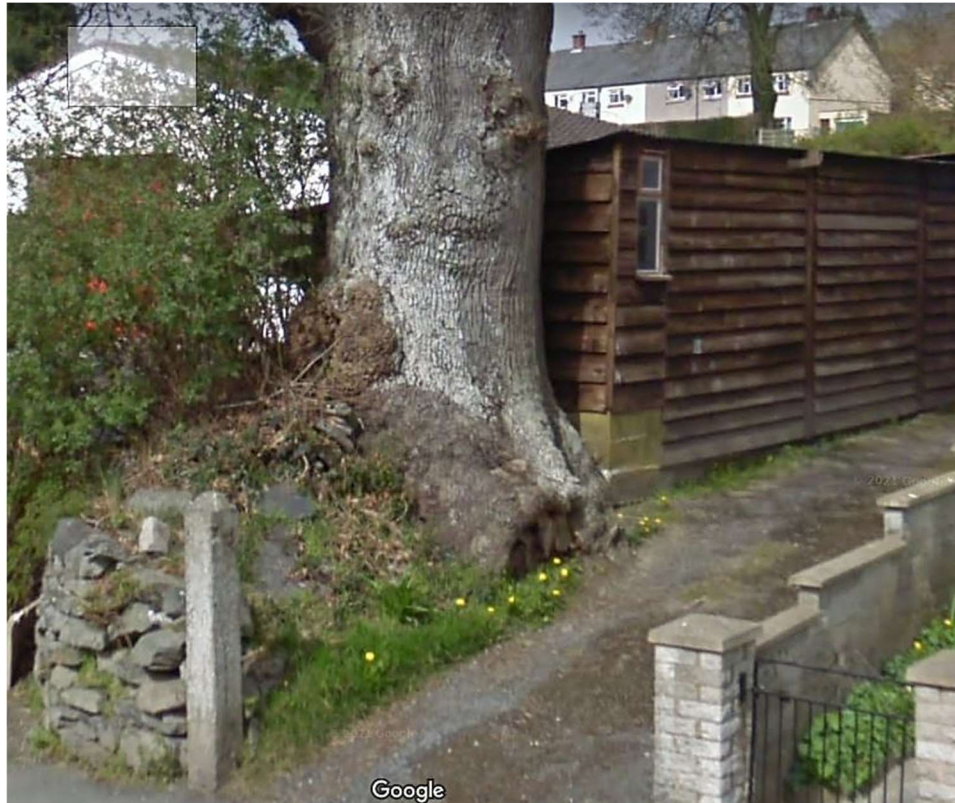
The tree has undergone several unsympathetic and excessive pruning interventions, resulting in a large decaying basal wound noted to the east, where a stem would have been removed. It is estimated that some 15 years ago this tree was excessively reduced with large decaying pruning wounds noted, supporting weakly attached regrowth, now forming a substantial part of the crown.

Photograph 1. Large basal wound to the east of the tree. An access driveway and house is within close proximity. The north bank has been excavated historically, with associated root severance, and with sheds now restricting access to that section of the stem.

- ✓ Climb and dismantle to ground level. **PRIORITY 1 (ASAP - within 1 month of the report).**
- ✓ Traffic Management (3 -way) will be required by a Specialist Traffic Management Company (East Street, A44).

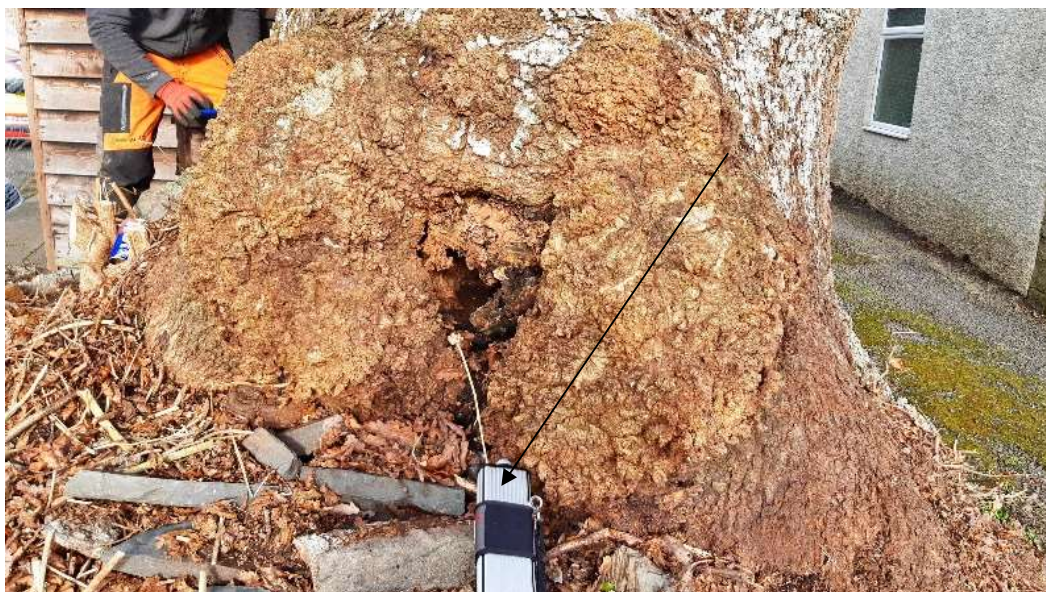
A basic resonance test using a sounding hammer was undertaken during the first site visit on the 17th Feb 2022, which detected basal decay in the lower stem and buttresses. A relatively small diameter basal cavity occurs to the south and its depth was probed to > 450-mm using a metal rod.

Photograph 2. Small diameter but deep basal decay cavity to the south. An operator undertaking an increment core sample is seen in the background. The IML PD-500 Resi Drill can be seen in the foreground (black arrow).

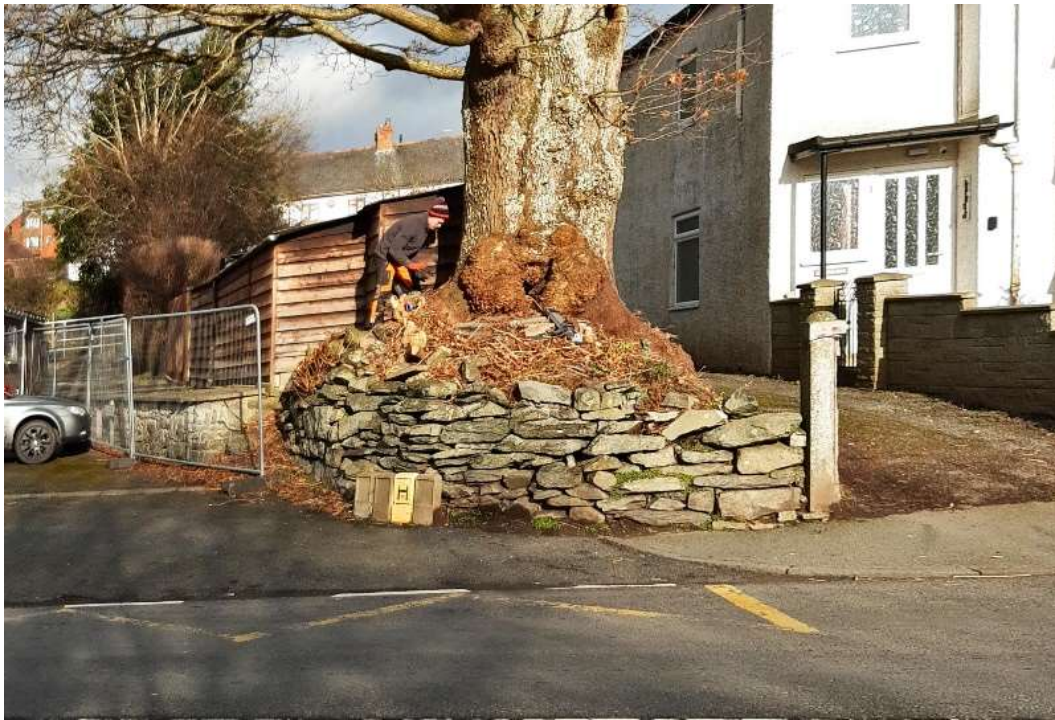
This tree has a very limited rooting area that has been significantly compromised on this narrow bank with some form of building or construction development occurring to all sides.

Immediately to the west lies the Fire Station and its Car Park, an access lane and house to the east with a highway and path to the south. The rooting area (hedge bank) immediately to the north has been historically excavated to the level of the access road, to accommodate the construction of sheds. The development activities will almost certainly have resulted in historic root severance, including some structural roots to compromise an already very much reduced rooting environment.

Photograph 3. Tree located on a narrow bank that is a remnant field boundary and now surrounded by development. This tree has a very limited rooting potential which has also been compromised, in addition to root severance.

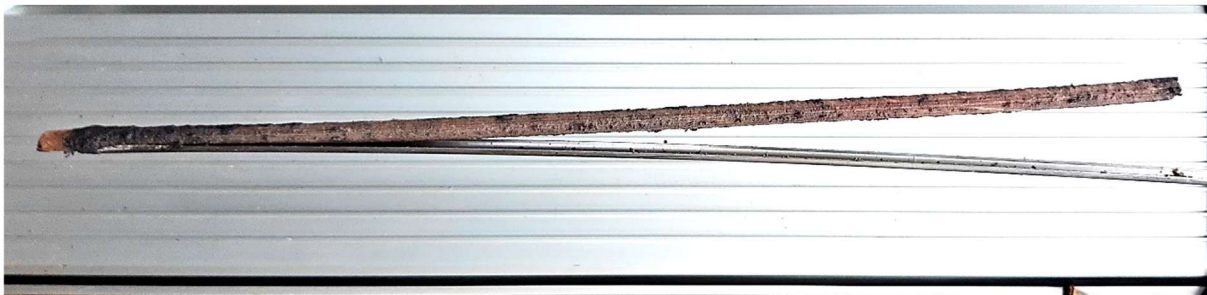
South-West = PASS

Photograph 4. Increment core sample – South-West.

Length of core	Distance inwards in mm. working from outside (bark) inwards	Bending moment in degrees	Breaking moment in Fractometer values	Colour range or Quality
290mm	40 -mm	15°	41 #	RED
	80 -mm	16°	84 #	YELLOW
	120 -mm	17°	91 #	GREEN
	160 -mm	16°	96 #	GREEN
	200 -mm	16°	83 #	YELLOW
Sample taken from...	240mm	15°	92 #	GREEN
Sample taken from...	SOUTH WEST @ 400mm AGL			
Visual description of findings

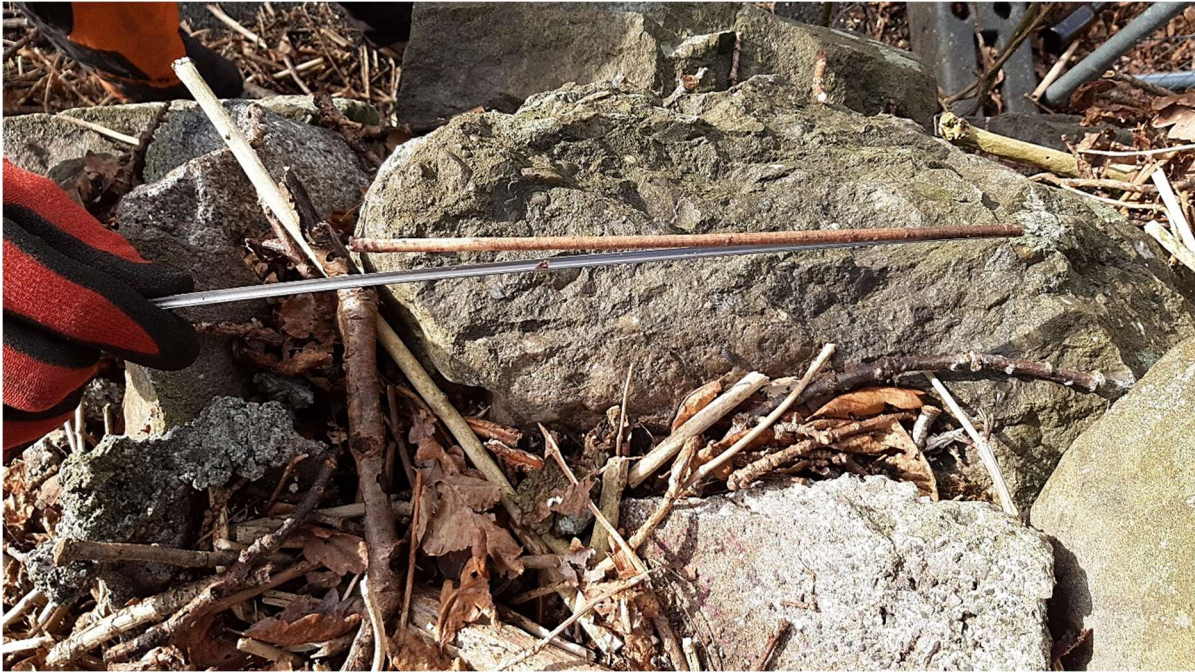
North-West = FAIL

Photograph 5. Increment core sample – North-West.

Length of core	Distance inwards in mm. working from outside (bark) inwards	Bending moment in degrees	Breaking moment in Fractometer values	Colour range or Quality
265mm	40 -mm	20°	54 #	RED
	80 -mm	20°	43 #	RED
	120 -mm	18°	47 #	RED
	160 -mm	16°	31 #	RED
	200 -mm	17°	44 #	RED
Sample taken from...	240mm	20°	40 #	RED
Sample taken from...	NORTH WEST @ 400mm AGL			
Visual description of findings

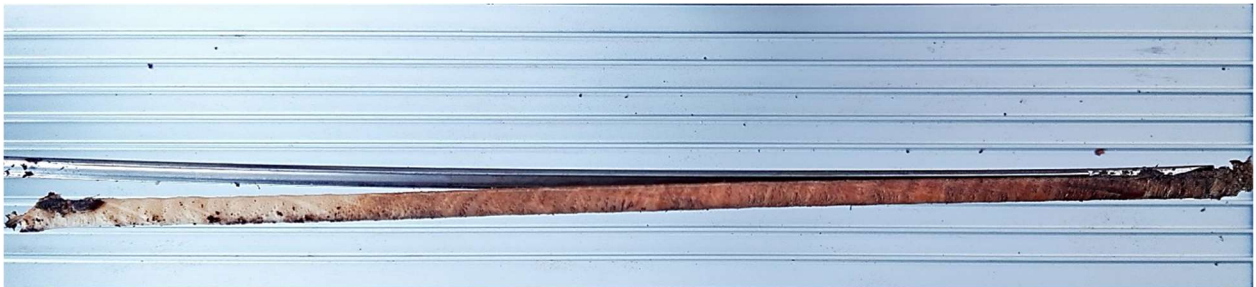
North-East = FAIL

Photograph 6. Increment core sample –North-East.

Length of core	Distance inwards in mm. working from outside (bark) inwards	Bending moment in degrees	Breaking moment in Fractometer values	Colour range or Quality
240mm	40 -mm SAP WOOD	10 °	48 #	RED
	80 -mm	16 °	48 #	RED
	120 -mm	16 °	77 #	YELLOW
	160 -mm	16 °	— #	
	200 -mm	13 °	79 #	YELLOW
Sample taken from... 240-mm 20° 46 RED				
Sample taken from... NORTH EAST @ 500mm AGL				
Visual description of findings SOFT / DECAY > 240mm.

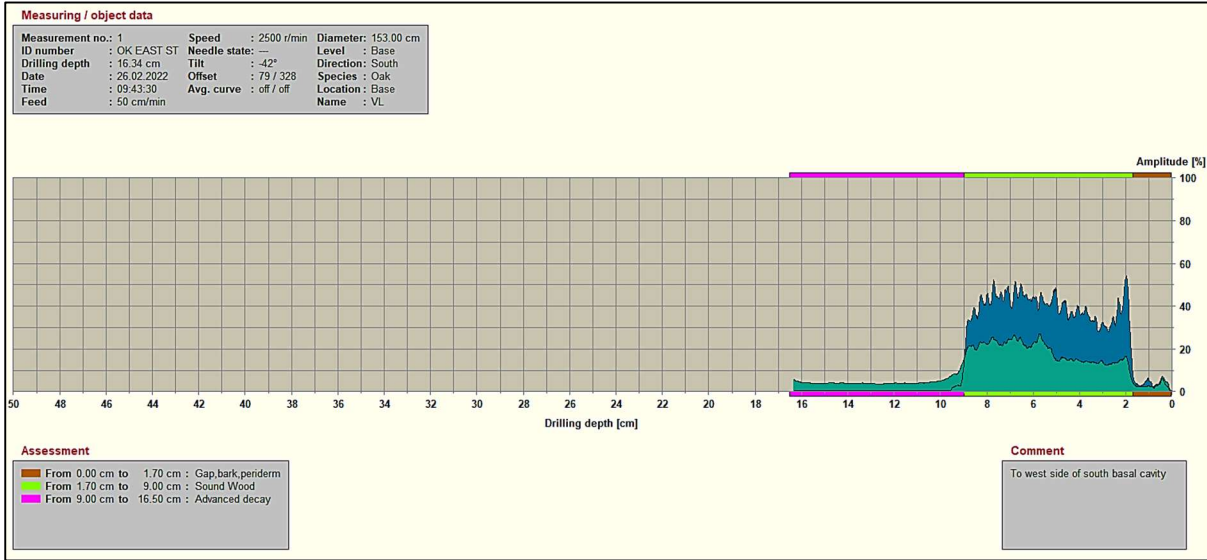
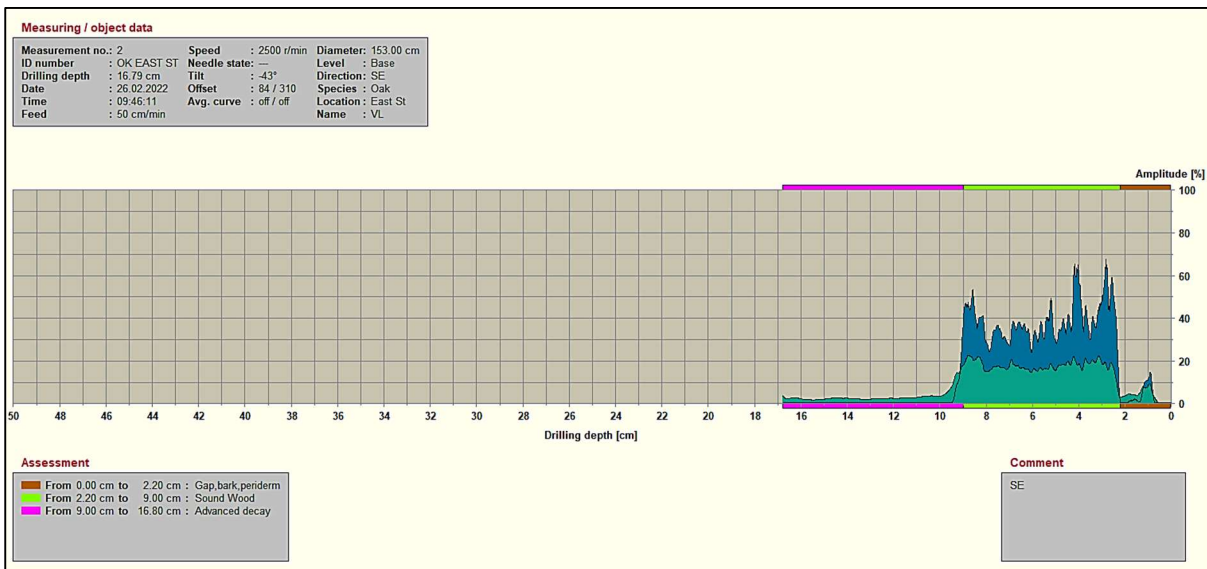
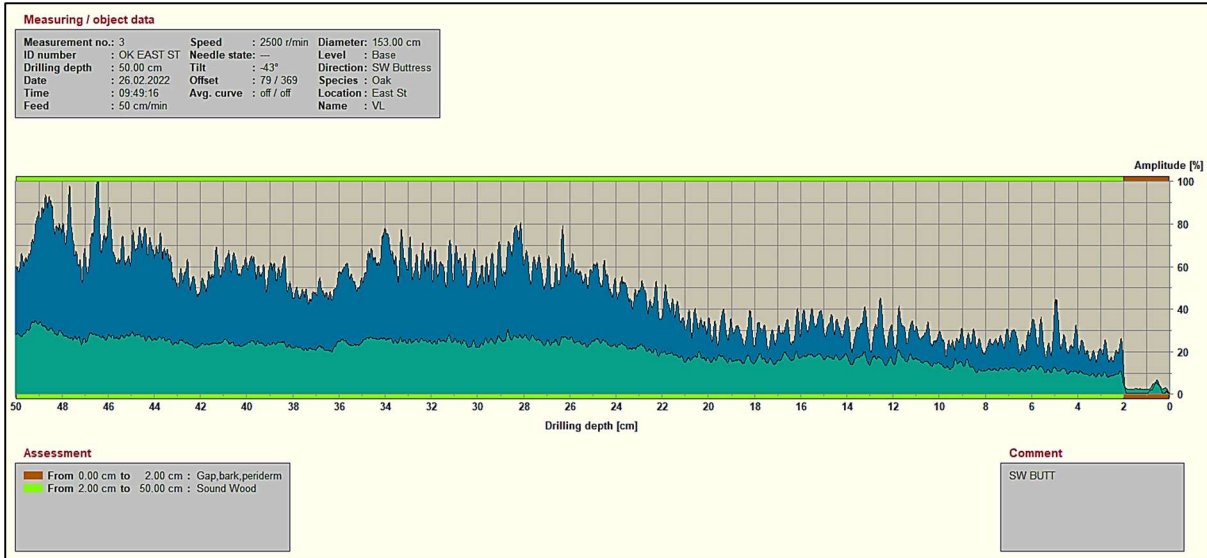
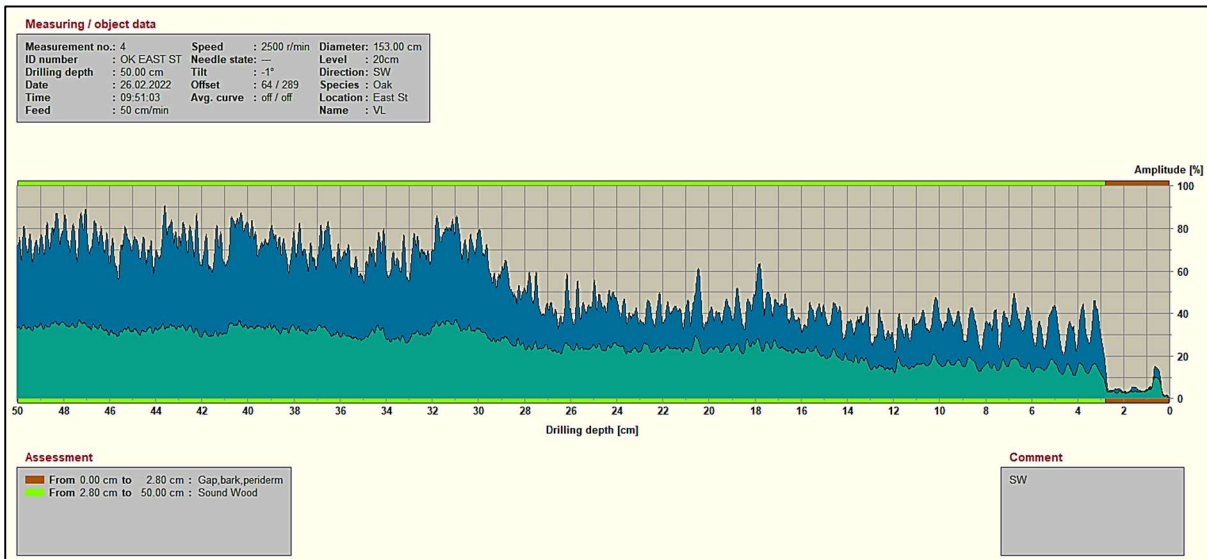
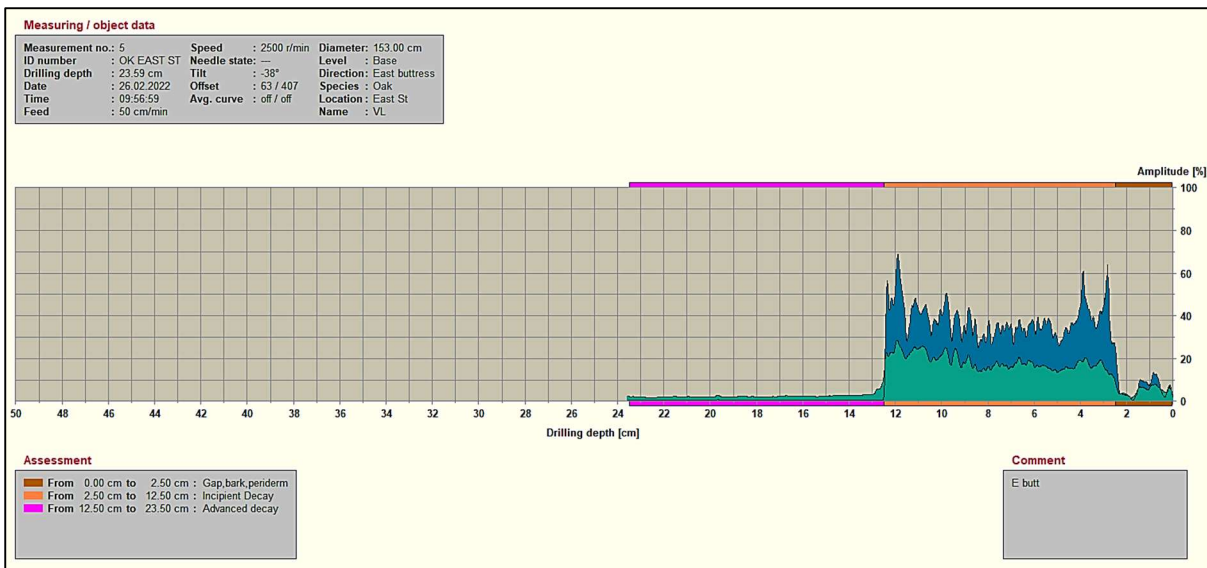
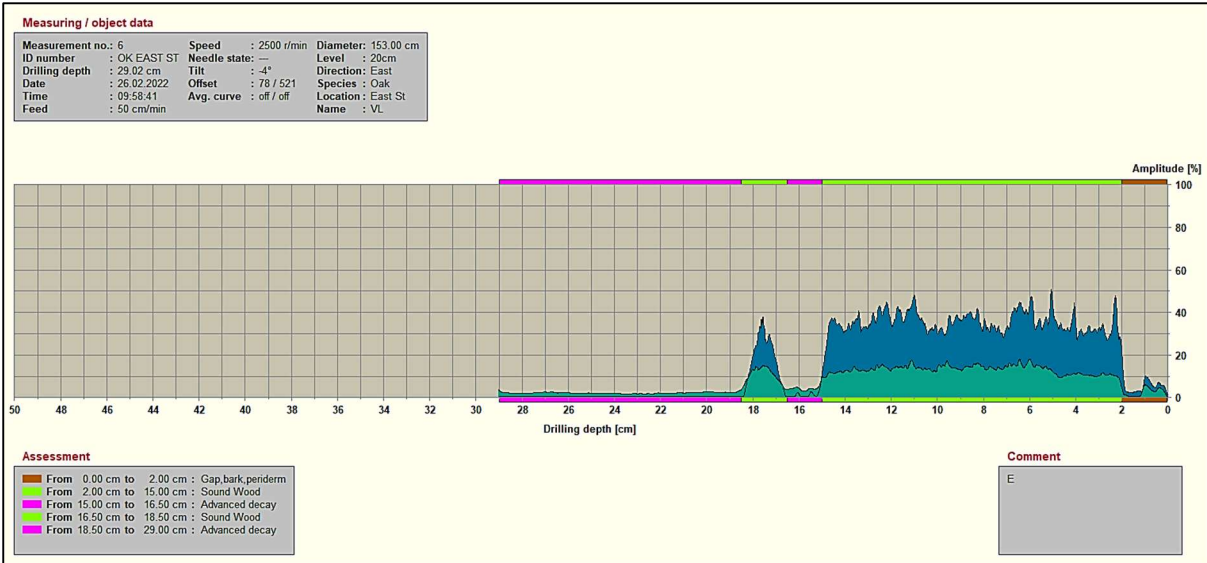
RESISTOGRAPH MEASUREMENTS

1. South at base (west side of cavity) = FAIL
2. South-east at base = FAIL
3. South-west buttress = PASS
4. South-west at 20-cm AGL = PASS
5. East buttress = FAIL
6. East at 20-cm AGL = FAIL
7. North-east at 20-cm AGL = FAIL
8. North-east at 20-cm AGL = PASS (decay occurs at 35-cm depth)

9. North-west at base = FAIL
10. North-west at 20-cm AGL = MARGINAL PASS
11. South-west at 1-m AGL = PASS
12. North-east at 1m AGL = PASS (decay occurs at 34-cm depth)
13. South-east at 1m = FAIL
14. North-east at 1-m AGL = FAIL

The lower stem and buttress decay is extensive mostly recorded in the basal stem measurements taken to the south, south-east, east, north-west, and within the east buttress measurements. The results from the north-west buttress measurement were marginal. The only sound wood seems to be restricted at the base to the south-west only, being the only side that passed the Fractometer testing. There are signs of fibre buckling (early failure) at the base of the stem where it meets the point of extensive decay this is caused as the weight of the tree and wind forces are transferred to this section. The tree's ability to respond to this loading through the formation of reactionary wood has been compromised due to the unsympathetic pruning, limited rooting potential and historic root severance.
